# DEVELOPMENT OF CBR DESIGN CURVES FOR HARVEY ALUMINUM LANDING MAT

MISCELLANEOUS PAPER NO. 4-615

January 1964

U. S. Army Engineer Waterways Experiment Station  
CORPS OF ENGINEERS  
Vicksburg, Mississippi

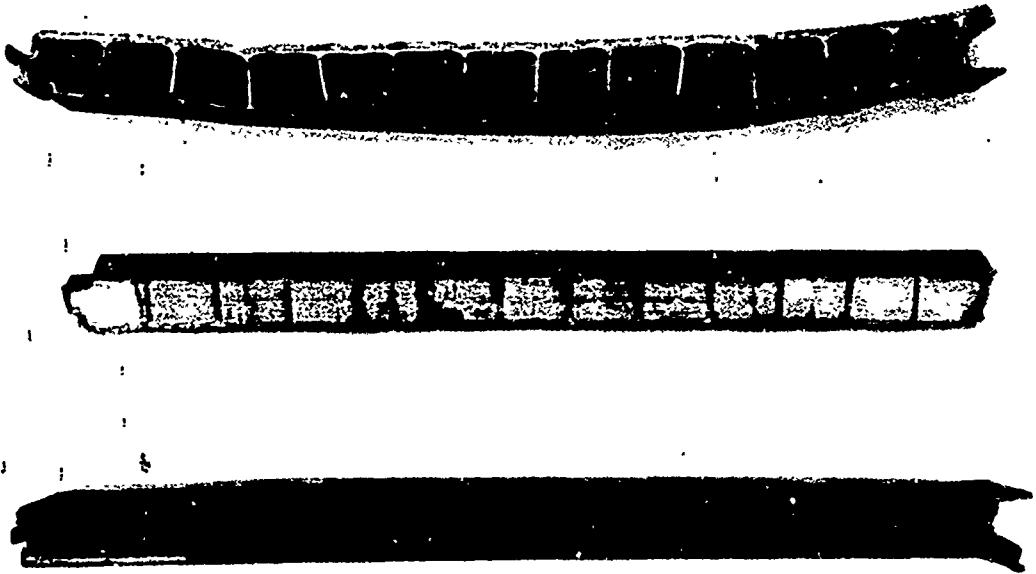
Close-ups of the core failure and the sheared end joint are shown in fig. 5.

Fig. 5. Close-up of core failure and end-joint failure

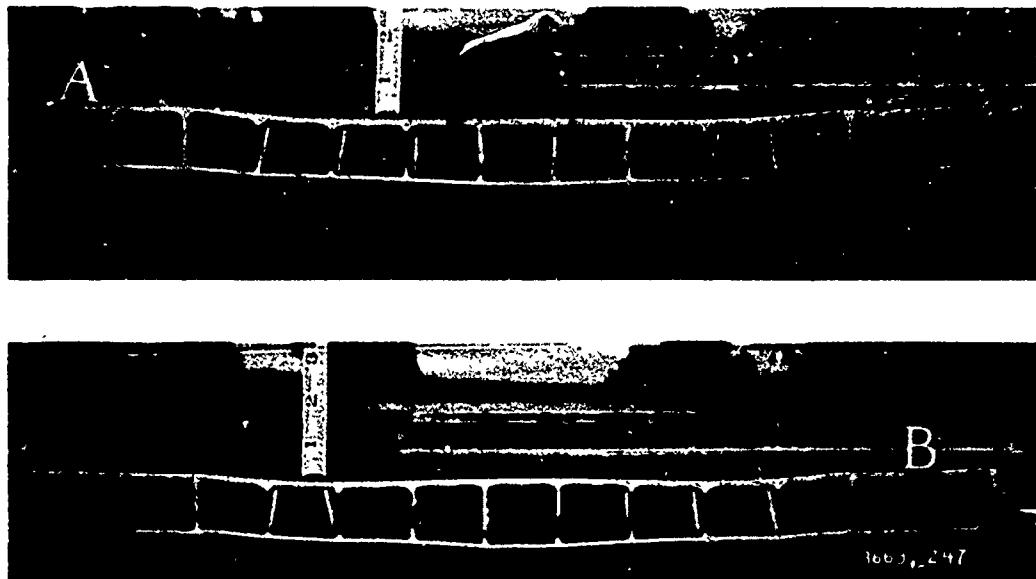
Fig. 7. Sawed section through depressed area, showing core failure

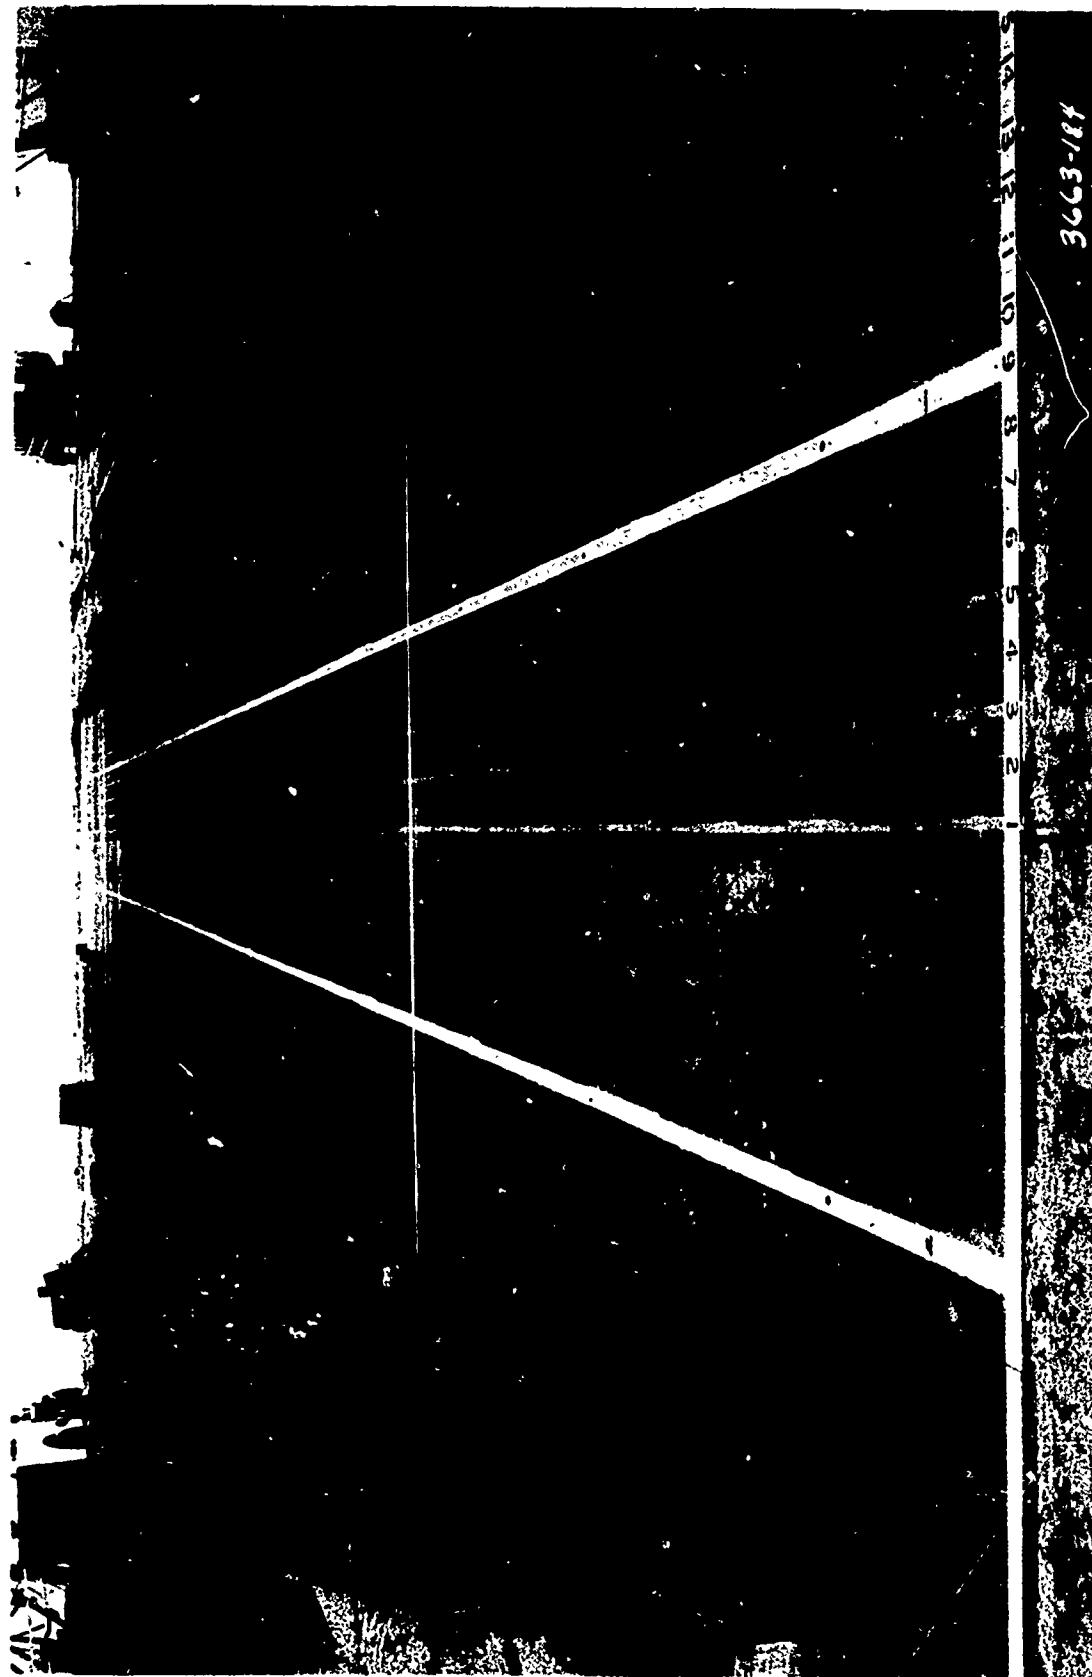
Photograph 2. Test section after placement of mat

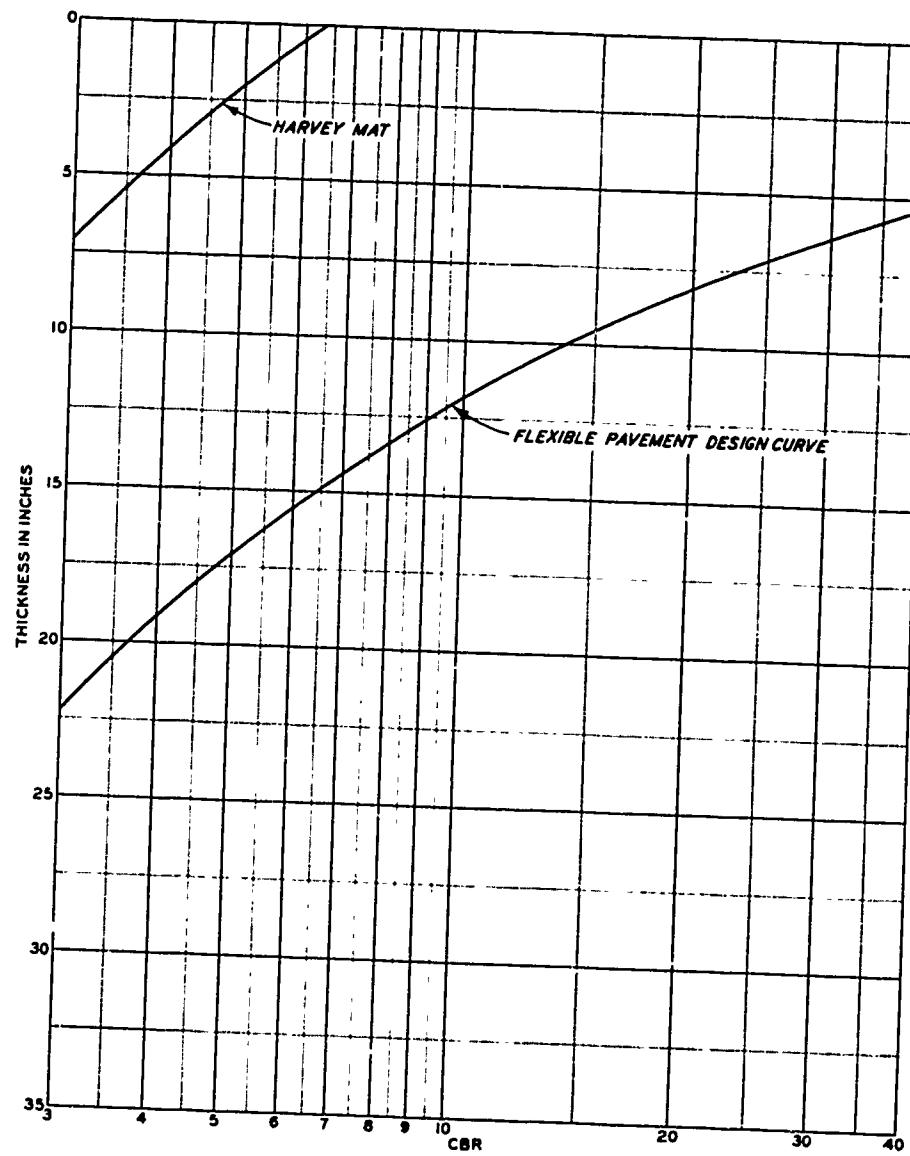
HARVEY ALUMINUM MAT  
CBR DESIGN CURVE  
27,000-LB SINGLE-WHEEL LOAD  
400-PSI TIRE PRESSURE  
188 COVERAGES

44. Plate 8 shows a CBR design curve for 188 coverages of a 27,000-lb single-wheel load with a tire pressure of 400 psi. The lower curve is a standard flexible pavement CBR design curve. The curve for the Harvey mat was developed as follows: In plate 7, it was shown that a subgrade with a CBR of 6.3 would satisfactorily support the 27,000-lb wheel load for 188 coverages when surfaced with the Harvey mat. It can be seen from plate 8 that a flexible pavement design based on a subgrade CBR of 6.3 would require 15.2 in. of base course. Thus, the Harvey mat is equivalent to 15.2 in. of base course. The design curve for the Harvey mat, also shown in plate 8, was obtained by taking 15.2 in. from the thickness indicated on the flexible pavement design curve for all CBR's less than 6.3.

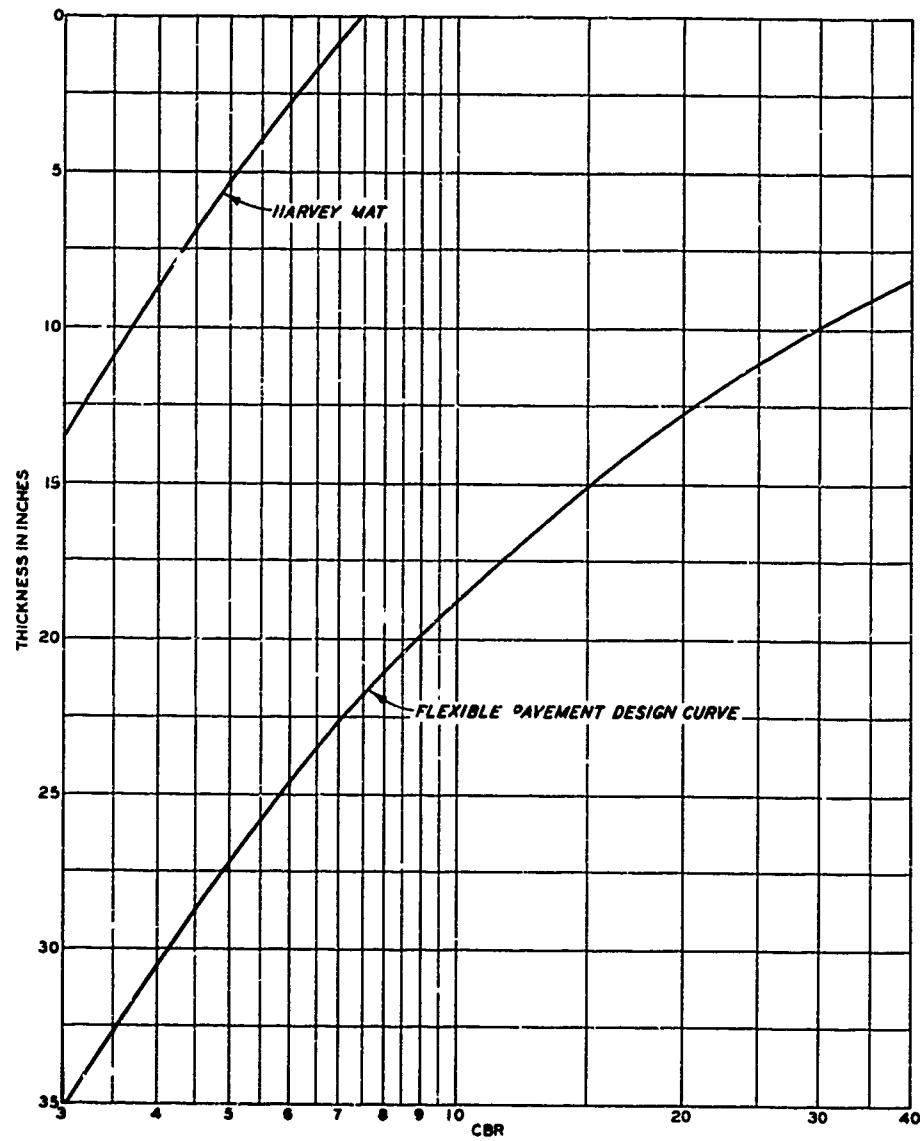
HARVEY ALUMINUM MAT  
CBR DESIGN CURVE  
39,000-LB SINGLE-WHEEL LOAD  
400-PSI TIRE PRESSURE  
1600 PASSES

47. A CBR design curve for 1600 passes of a 39,000-lb single-wheel load with 400-psi tire inflation pressure for the Harvey mat is shown in plate 10. This curve was developed, using the data in plate 9, in the same manner as that described in paragraph 44 for the 27,000-lb single-wheel load.
